PNG LNG Project: LNG Facilities

Hydrology and Sediment Transport

January 2009

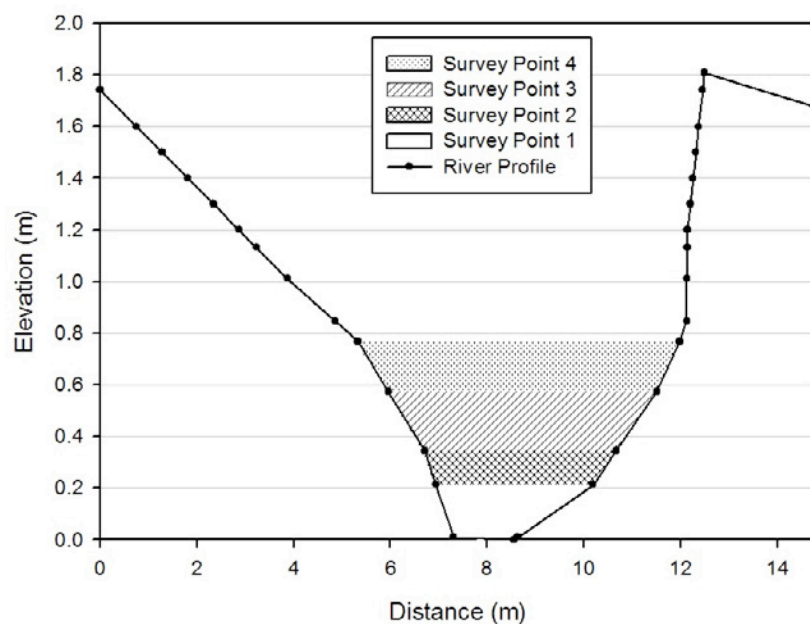
Figure 3-1 Vaihua River cross-section showing four examples of the different survey points at which channel characteristics were measured

where v = velocity (m / s), R = hydraulic radius (m), S = slope and n = “Manning’s n ” roughness coefficient. The hydraulic radius is defined as the cross-sectional area of a flow divided by the wetted perimeter (the parts of the channel “wetted” by the flow). Manning’s n was estimated in two ways to obtain an accurate estimate – with comparisons between photos of previous Manning’s n estimations (Barnes 1967, Hicks and Mason 1991) and *in situ* observations of Vaihua River and using a Manning’s n calculator, as described in Chow (1959). Both methods of determining Manning’s n returned similar values which provided confidence in the accuracy of the Manning’s n estimate.

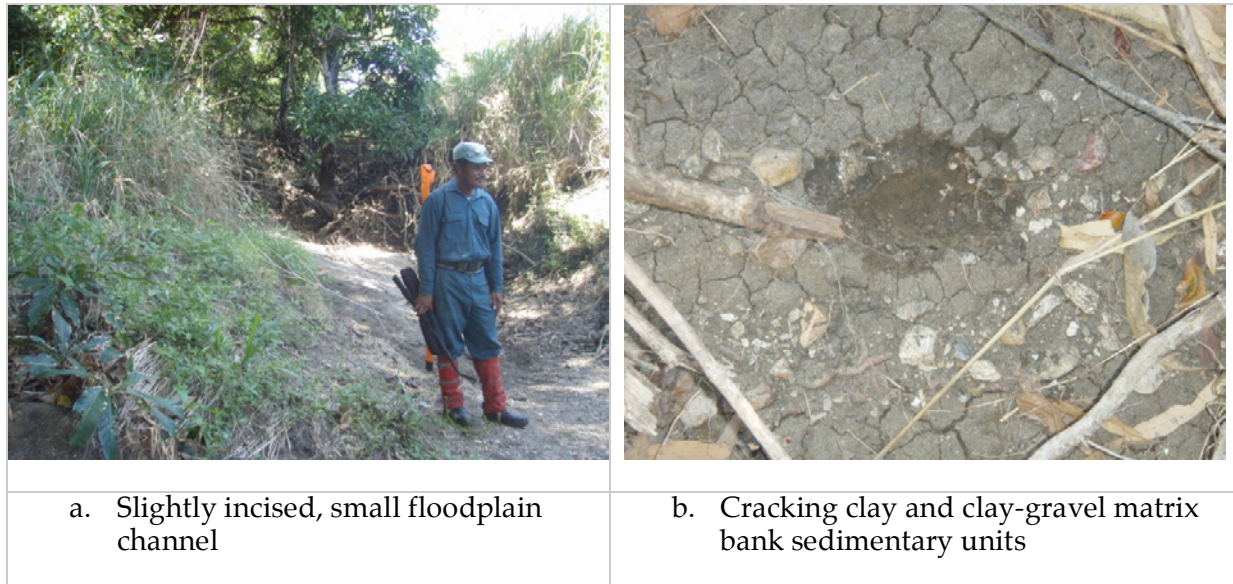
Figure 3-2 Geomorphic condition of floodplain channels

This region was flat with cracking clays, indicating poor drainage, which is typical of Gilgai country. The Vaihua River and its tributaries within this region were generally slightly incised streams with small cross-sectional area and with high potential for overbank flows (Figure 3-2a). Bank gradients varied between very gradual (VS5) and steep (VS2). Banks were generally composed of material with high clay content (VS2 – 42% clay; upper layer at VS3 – 29% clay), typical of Gilgai country; however, some locations consisted of banks with several sedimentary units. VS3, for example, had banks with three different units – a top layer of black clay, a middle layer of black clay with gravel and a bottom layer of black clay (Figure 3-2b). This is evidence of some past channel downcutting and lateral movement. The black soils within the banks were generally not dispersive (i.e. diffusion of sediment particles into water) but underwent complete aggregate slaking (fragmentation of soil aggregates) within seconds of immersion in water, indicating some weakness when wet (Figure 3-3). This has significant implications for bank stability during rainfall events and resulting stream flows.

Longitudinal channel slope was low throughout this region ($< 1^\circ$ at all sites). While past incision was evident, current trends within most floodplain channels appeared to be more of infilling, with large within-channel deposition zones of coarser sediment (Figure 3-4a). This sedimentation is likely to be an artefact of the drier conditions. Wet season flows will redistribute this sediment. Similar seasonal sedimentation occurs at the mouth fed by tidal redistribution and longshore drift of sediment, with mouth re-opening occurring during larger wet season flows.

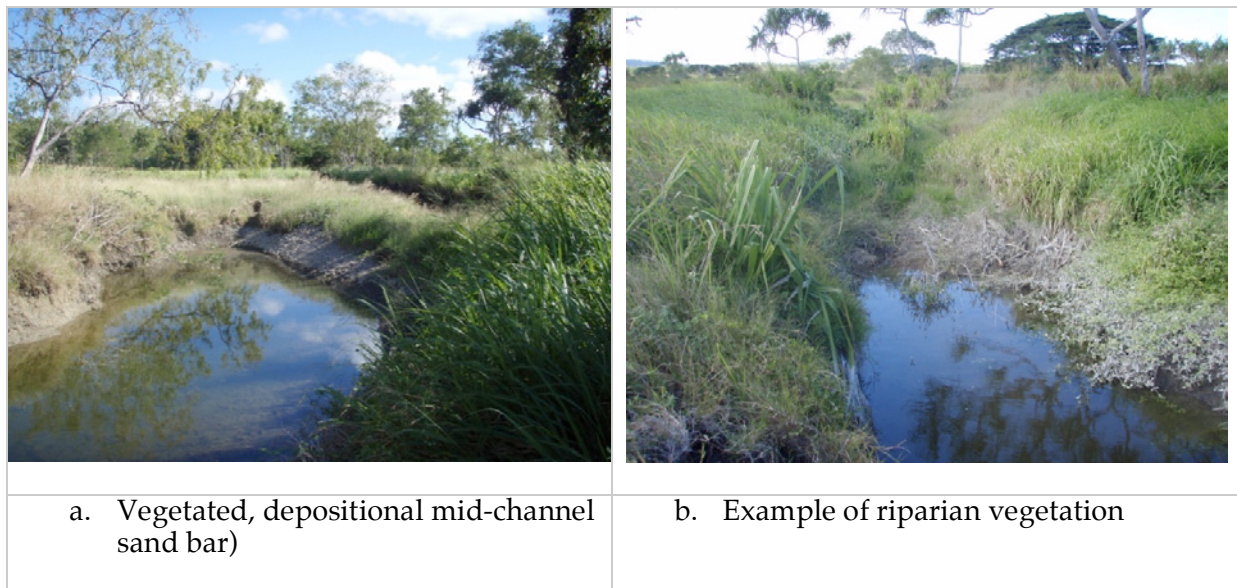
Figure 3-4 Examples of floodplain channel geomorphology and riparian condition

Riparian vegetation was variable and dependent on the presence of remnant standing water (suggesting the presence of some groundwater lenses). However, in general it consisted of scattered to low density trees and dense grasses (Figure 3-4b). As such, very little additional stabilising effect was offered via the root matrix.

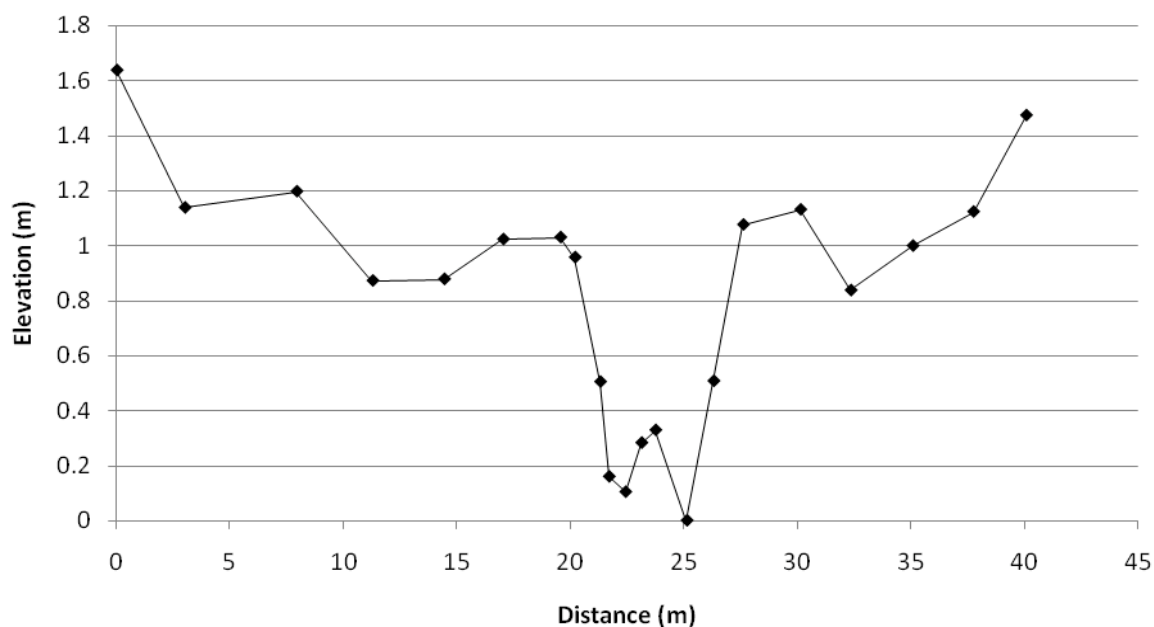
KS8

- wide, gradual sloped upper banks
- shallow active channel
- shallow bankfull, but wide
- sandy gravel bed (similar to other Karuka sites)
- silty clay bank with sand / gravel
- no dispersion
- irregular meandering
- grassed on both banks
- 4 or 5 trees / 100m² quadrat
- stable banks
- fast flowing
- fast ebbing
- relatively flat, narrow floodplain at this point (compared with other Karuka sites) with undulating surface - moderately confined by surrounding landscape
