# Soil Impact Assessment and Rehabilitation study for the PNG LNG Project: Portion 152 LNG Facility

Coffey Natural Systems

December 2008

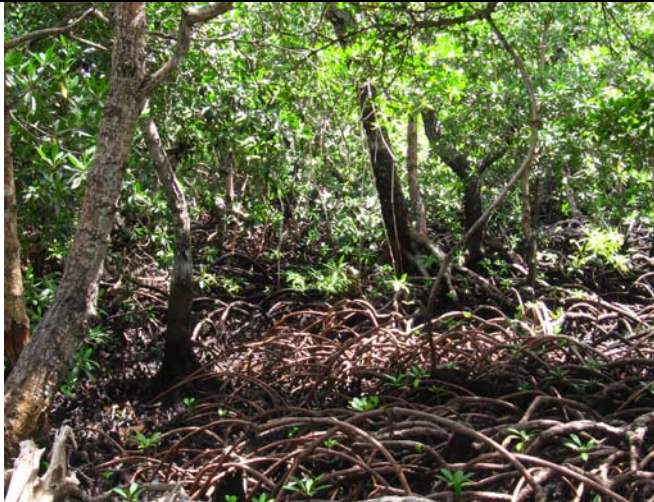
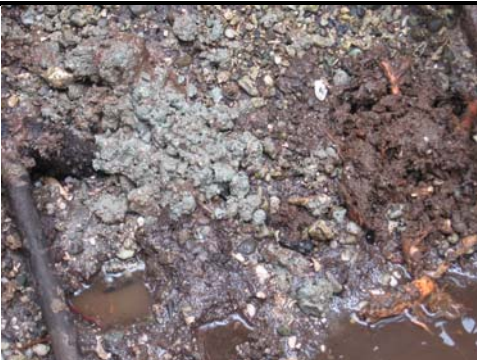
Soil Type	Site No: P1	Date: 19/4/2008
<b>Concept</b> Grey mangrove soils with a potential for acid sulfate soils. Dominated by the common mangrove trees <i>Rhizophera</i> sp., <i>Bruguiera</i> sp. and occasional <i>Sonneratia alba</i> .

GPS (WGS): S9 19.449 E147 00.164		
Height ASL: < 1 m		
Soil Classification: Soil Order: Entisol; Suborder:Aquents; Great Group: Sulfaquent		
Landform Element	Seaward mangroves	
Landform Pattern	Mangrove	
Slope	Flat	
Microrelief	Flat	
Surface condition	Exposed soil, shells and abundant tangled roots	
Land Condition	Undisturbed mangroves	
Land Use	None	
Erosion/ASWAT	Not tested	
Vegetation and Type	Mangroves dominated by <i>Rhizophera</i> and <i>Bruguiera</i>	
PNGRIS Type	Mangroves	
Samples for analysis	Yes	
Rehabilitation Suitability Summary :

Horizon	Depth (cm)	Description
	A	20	Peaty material
	B	20 - > 150	Blue grey mangrove soil with occasional mottles
	Recommended Topsoil Strip Depth		NA

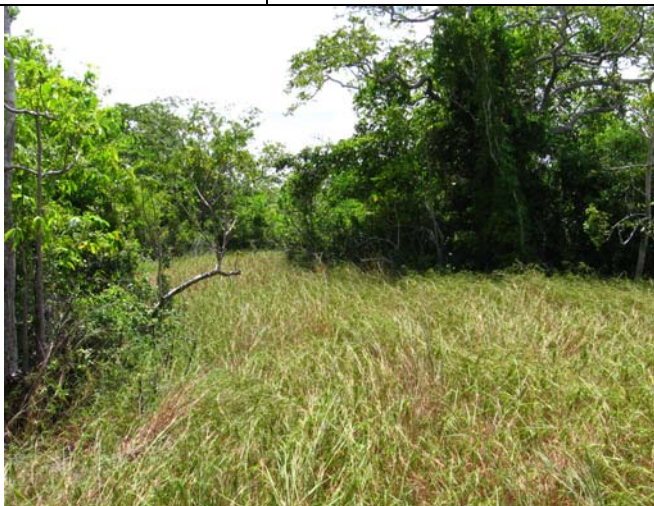
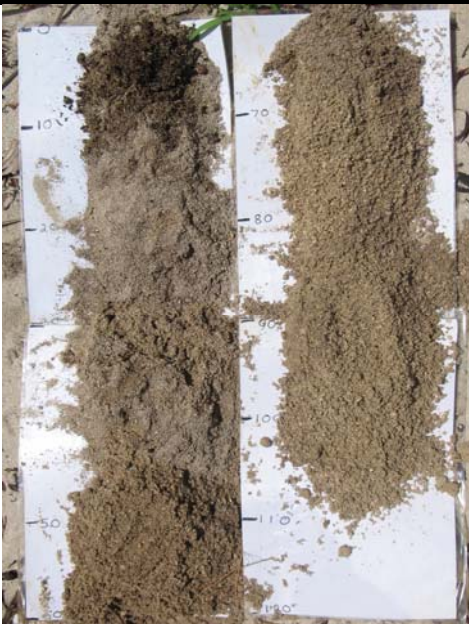
Soil Type	Site No: P2	Date: 19/4/2008
<b>Concept</b> Sandy soil on small sand dune/beach ridge adjacent to the sea. Dominated by patches of monsoonal forest and grasses, particularly the grass <i>Themeda</i> .  Species (grassland): <i>Cleome viscosa</i> *, <i>Fimbristylis</i> sp., <i>Iresine</i> sp.* , <i>Melinis repens</i> *, <i>Themeda arguens</i>  Species (monsoonal forest): <i>Aegiceras</i> sp., <i>Bombax ceiba</i> , <i>Cayratia</i> sp*., <i>Celtis</i> sp., <i>Citrus</i> sp. <i>Eurya</i> sp. <i>Ficus</i> sp., <i>Gmelina</i> sp. <i>Ipomea pes-caprae</i> , <i>Lysiphyllum</i> sp., <i>Omorocarpum</i> sp., <i>Passiflora foetida</i> *, <i>Pandanus dubius</i> , <i>Polytoca</i> sp., <i>Premna obtusifolia</i> , <i>Roetboellia exaltata</i> .  * Weeds

GPS (WGS): S9 19.452 E147 00.164		
Height ASL: < 5 m		
Soil Classification: Soil Order: Entisol; Suborder: Psamments; Great Group: Tropopsamments

0.6 m	<b>Horizon</b>	<b>Depth (cm)</b>	<b>Description</b>
0.1 m		0.7 m	A	5	Sand Field pH 8.5
0.2 m		0.8 m	B	5 - > 100	Sand Coarse sand from 60 cm + Field pH 8.5
0.3 m		0.9 m	<b>Recommended Topsoil Strip Depth</b>		5 - 10 cm
0.4 m		1.0 m			
0.5 m		1.1 m

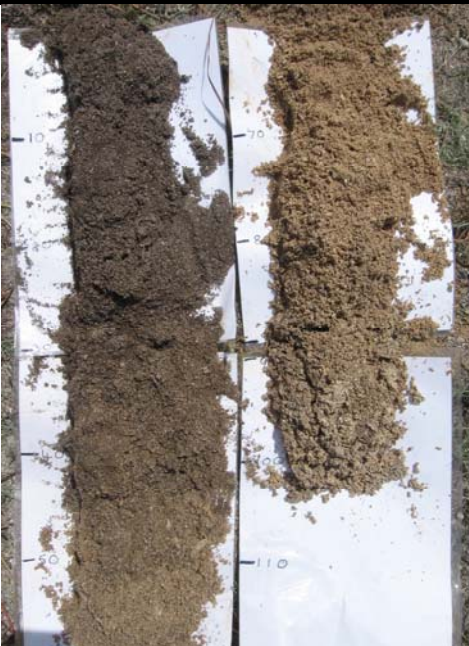
Soil Type	Site No: P3	Date: 19/4/2008
<b>Concept</b> Sandy soil on low and narrow sand dune/beach ridge adjacent to the sea. Dominated by grasses.  Species: <i>Euphorbia hirta*</i> , <i>Euphorbia serulata</i> , <i>Heteropogon contortus</i> , <i>Sesuvium portulacastrum</i> , <i>Themeda arguens</i> , <i>Thunbergia erecta</i>

0.6 m	<b>Horizon</b>	<b>Depth (cm)</b>	<b>Description</b>
0.1 m		0.7 m	A	30	Sand Field pH 8.5
0.2 m		0.8 m	B	40 - > 100	Sand Coarse sand from 60 cm + Field pH 8.5
0.3 m		0.9 m	<b>Recommended Topsoil Strip Depth</b>		30 cm
0.4 m		1.0 m	<b>Preferred Rehabilitation Application</b>		
0.5 m		1.1 m

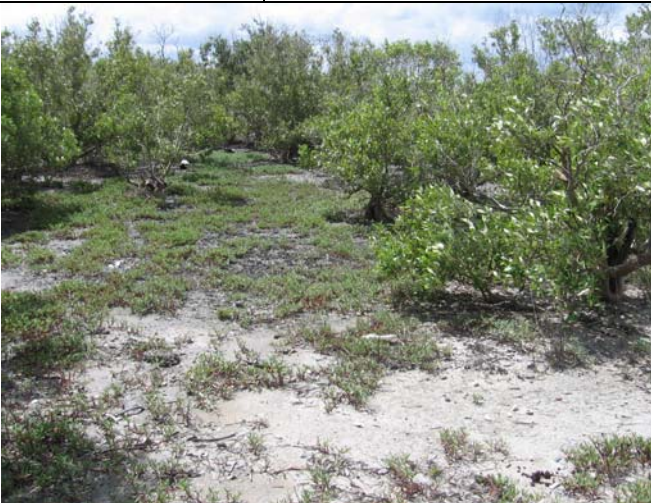
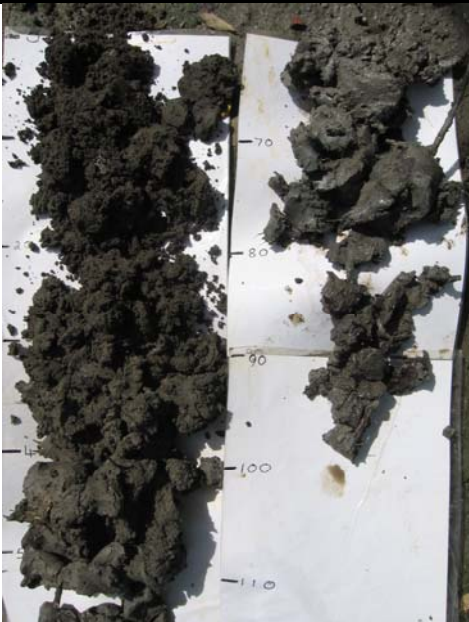
Soil Type	Site No: P4	Date: 19/4/2008
<b>Concept</b> Mangrove back swamp behind fore-dune/beach ridge. Soil has ASS potential.  Species: <i>Avicennia marina</i> and <i>Sesuvium portulacastrum</i> .

GPS (WGS): S9 19.538 E147 00.197		
Height ASL: < 1 m		
Soil Classification: Soil Order: Entisol; Suborder:Aquents; Great Group: Sulfaquent		
Landform Element	Back swamp margin	
Landform Pattern	Back swamp	
Slope	Flat	
Microrelief	Flat	
Surface condition	<i>Sesuvium portulacastrum</i> and exposed soil	
Land Condition	Minor disturbance	
Land Use	None	
ASWAT	Unstable	
Vegetation and Type	Mangrove dominated by <i>Avicennia marinara</i>	
PNGRIS Type	Mangrove	
Samples for analysis	Yes	
<b>Rehabilitation Suitability Summary :</b> Topsoil salvage may be problematic because of ASS potential

0.6 m	Horizon	Depth (cm)	Description
0.1 m		0.7 m	A	40	Silty clay Field pH 9 – 9.5
0.2 m		0.8 m	B	40 - > 100	Silty clay Field pH 9 – 9.5 Thin organic layer at 1 m
0.3 m		0.9 m	<b>Recommended Topsoil Strip Depth</b>		
0.4 m		1.0 m			
0.5 m		1.1 m

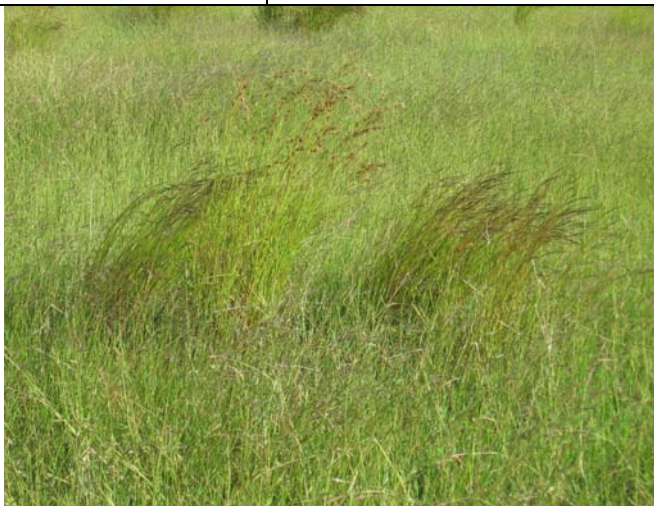
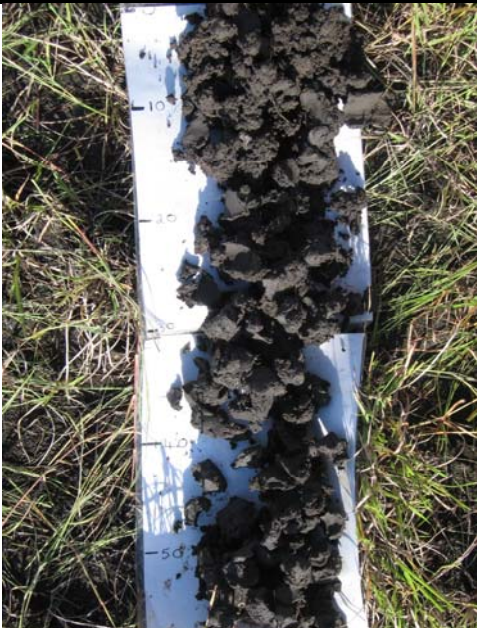
Soil Type	Site No: P7	Date: 19/4/2008
<b>Concept</b> Gently sloping cracking clay plain.  Species: <i>Heteropogon contortus</i> and <i>Themeda</i> sp.

GPS (WGS): S9 19.510 E147 00.659		
Height ASL: < 10 m		
Soil Classification: Soil Order: Vertisol		
Landform Element	Gentle rise of clay plain	
Landform Pattern	Clay plain	
Slope	< 5°	
Microrelief	Flat	
Surface condition	Black cracking clay and grass litter	
Land Condition	Man-made grassland. Probably burned each year	
Land Use	No current use. Was part of Fairfax cattle station	
Erosion/ASWAT	Unstable	
Vegetation and Type	Grassland dominated by <i>Heteropogon contorta</i> and <i>Themeda arguens</i>	
PNGRIS Type	Non-forested	
Samples for analysis	Yes	
<b>Rehabilitation Suitability Summary :</b> Top soil is about 5-10 cm depth. The top soil will typically contain a seedbank which will be dominated by grasses. These soils are best handled in the dry season. Wet clays will be difficult to reapply as a rehabilitation medium and will be prone to compaction damaging the soil.

Horizon	Depth (cm)	Description
A	5-10	Very stiff clay Field pH 6.5
B	40 - > 100	Very stiff clay Field pH 6.5
<b>Recommended Topsoil Strip Depth</b>		10 cm

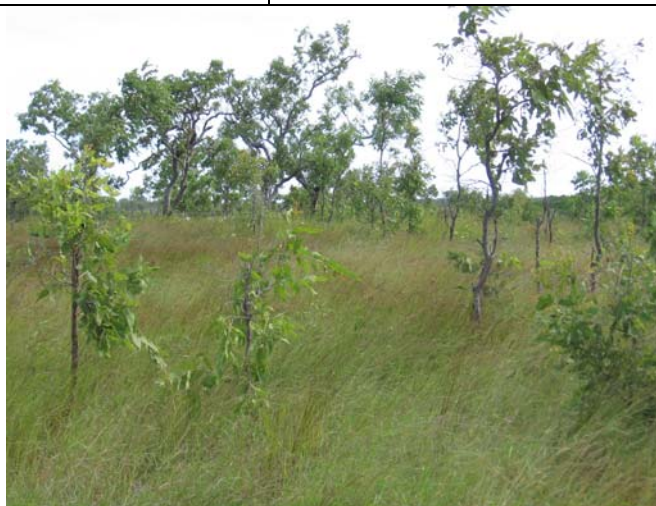
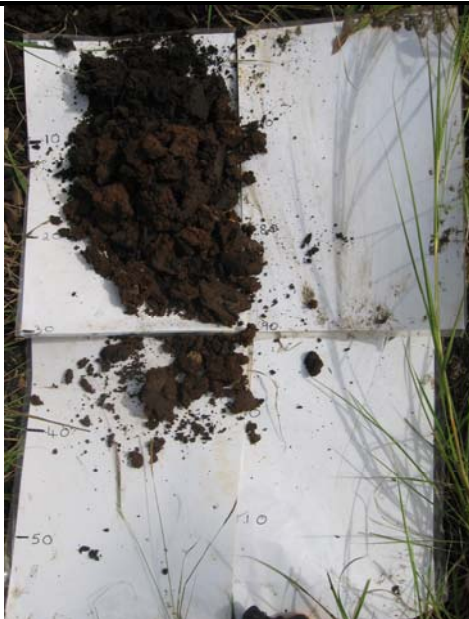
Soil Type	Site No: P13	Date: 19/4/2008
<b>Concept</b> Limestone hill/terrace overlain by clay supporting eucalypt savanna and grasslands.  Species: <i>Crotalaria</i> sp., <i>Glorchidion</i> sp., <i>Desmodium</i> sp. <i>Heteropogon contortus</i> , <i>Eucalyptus teriticornis</i> , <i>Mimosa</i> sp., and <i>Themeda</i> sp.

GPS (WGS): S9 21.143 E147 01.368		
Height ASL: 8 m		
Soil Classification: Soil Order: Vertisol		
Landform Element	Raised clay plain	
Landform Pattern	Terrace	
Slope	Flat	
Microrelief	Flat	
Surface condition	Cracking clay and grass litter with occasional limestone outcrops	
Land Condition	Man-made grassland. Probably burned each year	
Land Use	No current use. Was part of Fairfax cattle station	
ASWAT	Unstable	
Vegetation and Type	Eucalypt savanna with a grassland groundlayer dominated by <i>Heteropogon contorta</i>	
PNGRIS Type	Non-forested	
Samples for analysis	Yes	
<b>Rehabilitation Suitability Summary :</b> Top soil is about 8 cm depth. The top soil will typically contain a seedbank which will be dominated by grasses. These soils are best handled in the dry season. Wet clays will be difficult to reapply as a rehabilitation medium and will be prone to compaction damaging the soil.

Horizon	Depth (cm)	Description
0.1 m		A	8	Very stiff dark brown clay Field pH 7
0.2 m		B	8 - 40	Very stiff dark orange brown clay with limestone fragments Field pH 7 – 7.5 Limestone at 40 – 60 cm
0.3 m		<b>Recommended Topsoil Strip Depth</b>		10 cm
0.4 m				
0.5 m
