NEARSHORE MARINE IMPACT ASSESSMENT

Esso Highlands Limited

PNG LNG Project

CR 1284_5_v1

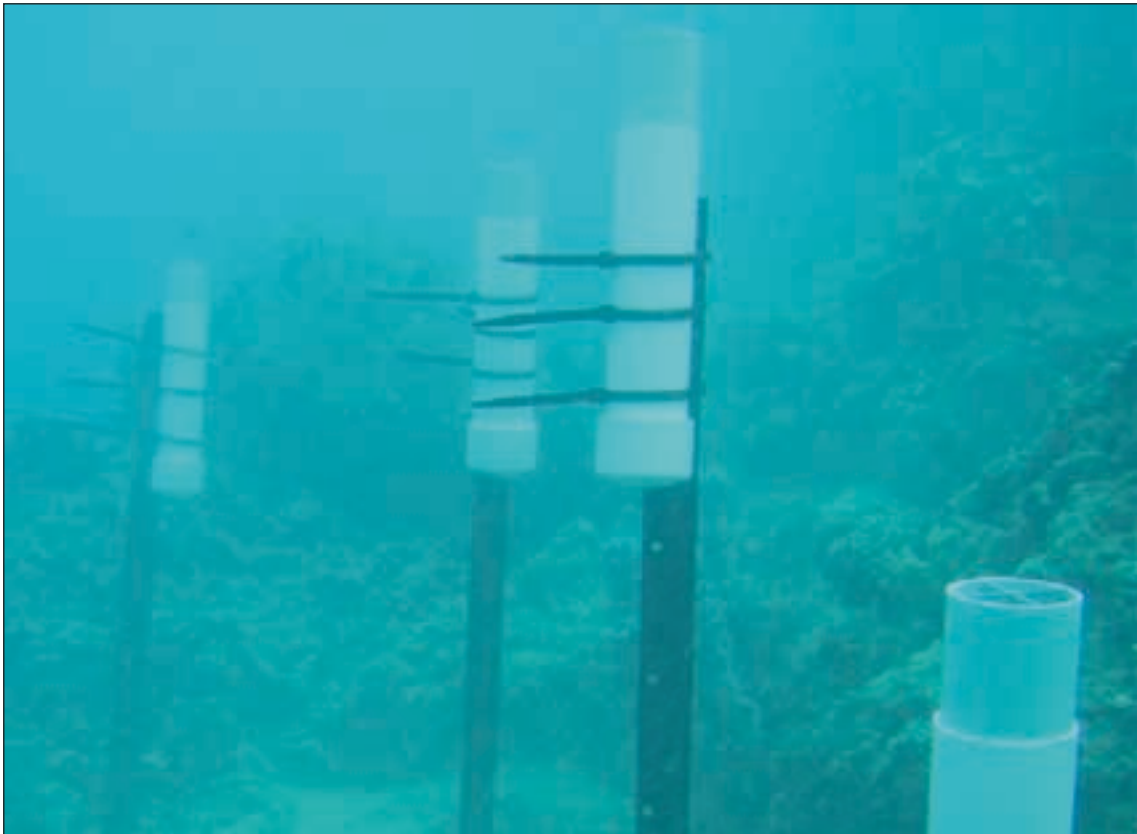
Plate 3.04
Group of installed sediment traps

The sedimentation traps have been designed for deployment in replicate groups, 2 m apart. Four individual traps were installed at each station in water depths of at least 5 m and were fixed approximately 1.5 m above the seafloor to star pickets driven into the benthic substrate (Plate 3.04).

Seven sediment traps were installed in December 2007 within Caution Bay to measure sedimentation rates in the nearshore environment (see Figure 3.02). Sediment trap design is based on that developed by the Australian Institute of Marine Science (AIMS) for data collection along the Great Barrier Reef, Australia. Each trap consists of a polyvinyl chloride (PVC) collection tube, 300 mm long with a 50 mm diameter opening, which is held within a larger diameter outer tube such that the inner collection tube can be recovered and replaced at intervals. A plastic baffle is inserted at the top of the inner collection tube, which inhibits the resuspension and loss of sediment from the trap that may be caused by wave action or strong currents. The use of these baffles follows recommendations made by Hargrave and Burns (1979) and Gardner (1980).

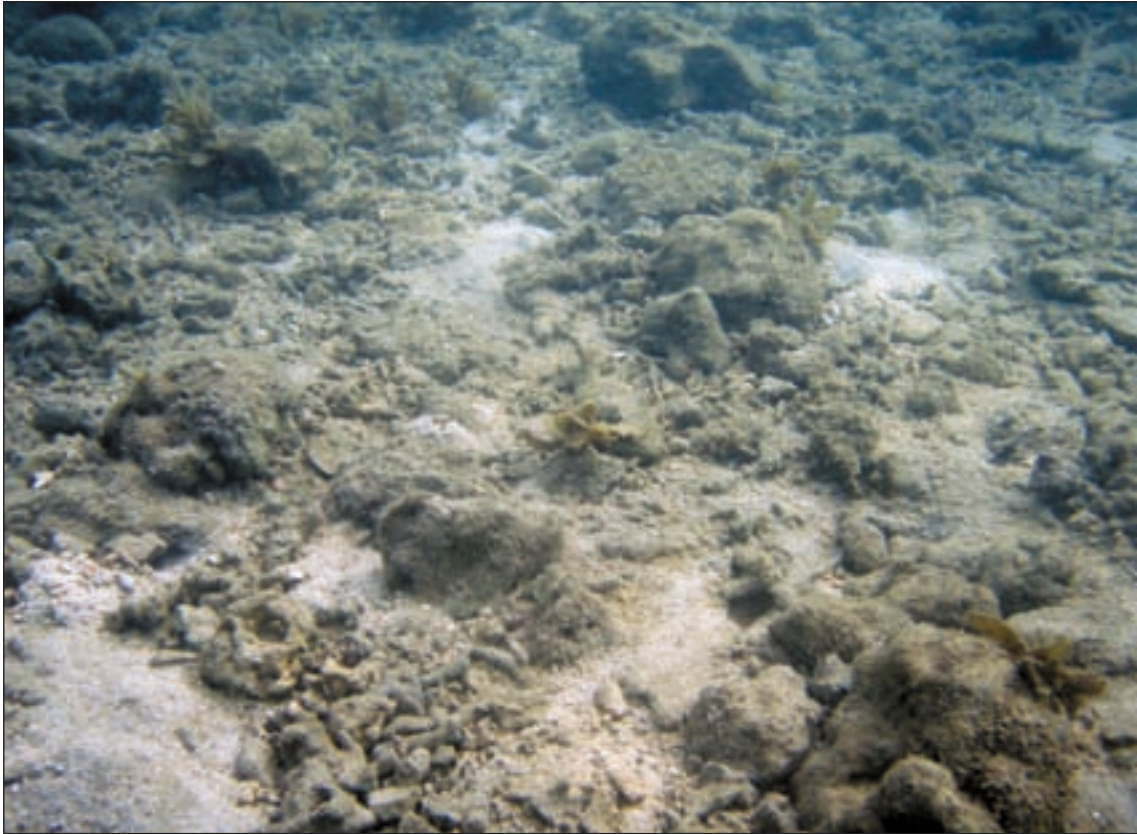
Plate 3.08
Dead coral and rubble

The majority of nearshore coral reefs within Caution Bay were degraded with very low coral and fish abundance. The damage has possibly been caused by extensive local dynamite fishing and subsequent storm events and other fishing practices (Plate 3.08). A number of local fishing boats and canoes were observed in Caution Bay during the study. Locals were observed actively fishing using spears, line and nets and collecting sea cucumbers for the Bech-der-mer industry within inshore coastal waters of Caution Bay. Discussions with local fisherman indicated that dynamite fishing has been undertaken in Caution Bay in recent times; however, no fresh evidence of dynamite fishing was apparent during the surveys. Most rubble was observed to be covered in algal or bacterial films indicating some time had past if the rubble was caused by dynamite fishing.

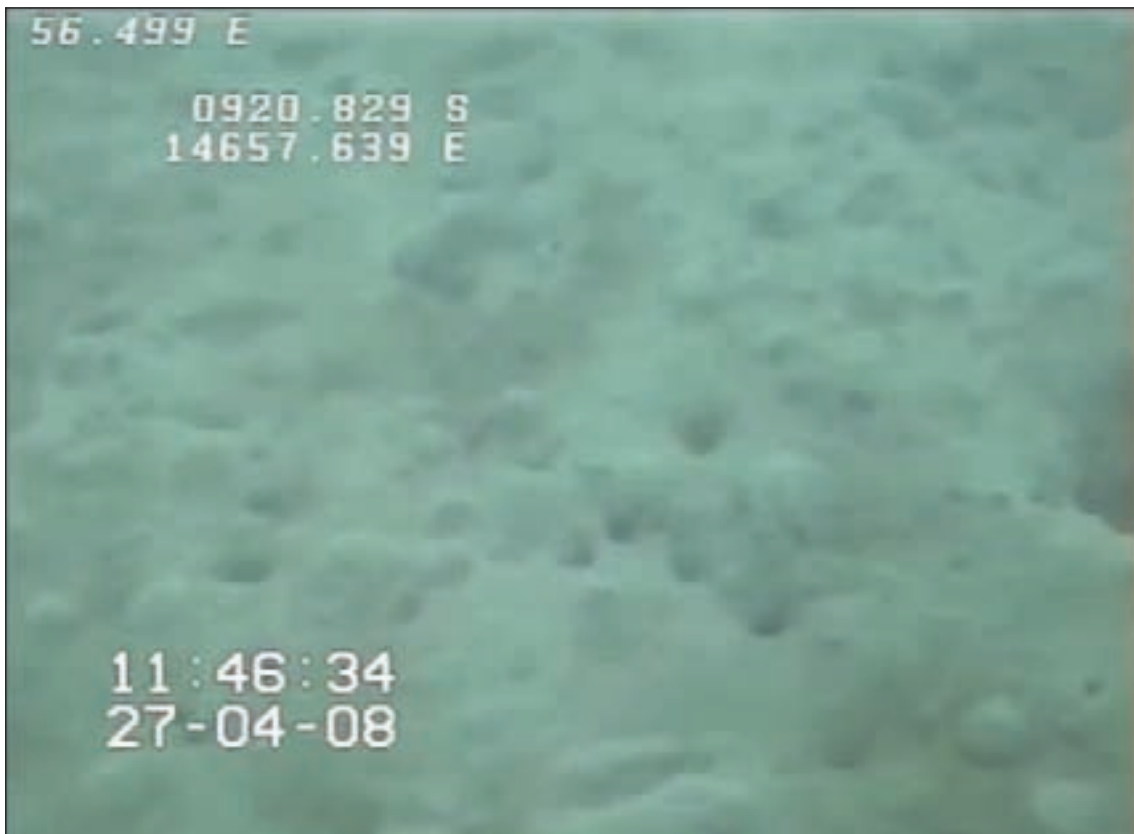
Plate 3.22 Drop camera video footage showing low visibility due to increased suspended sediments and little visual evidence of flora and fauna

although bioturbation (burrows and pits) evident at most sites investigated suggest biological activity of benthic infauna occurs in these areas (Plate 3.22).

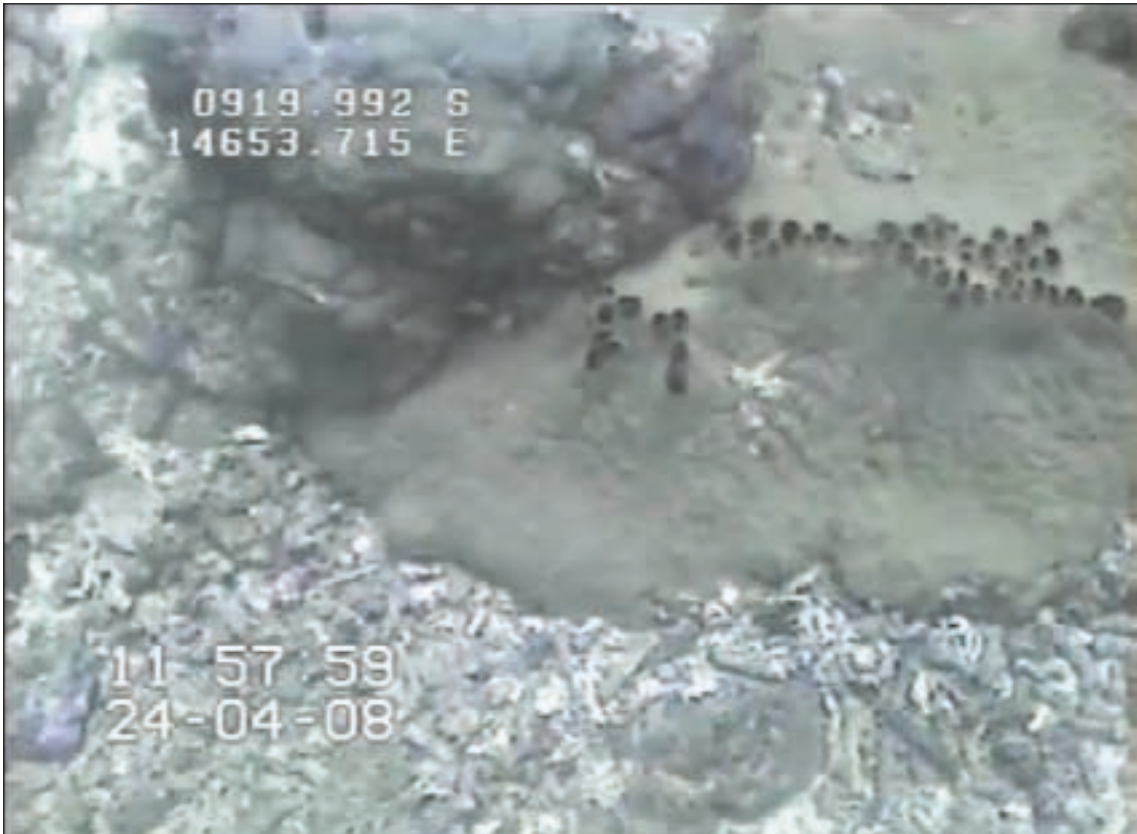
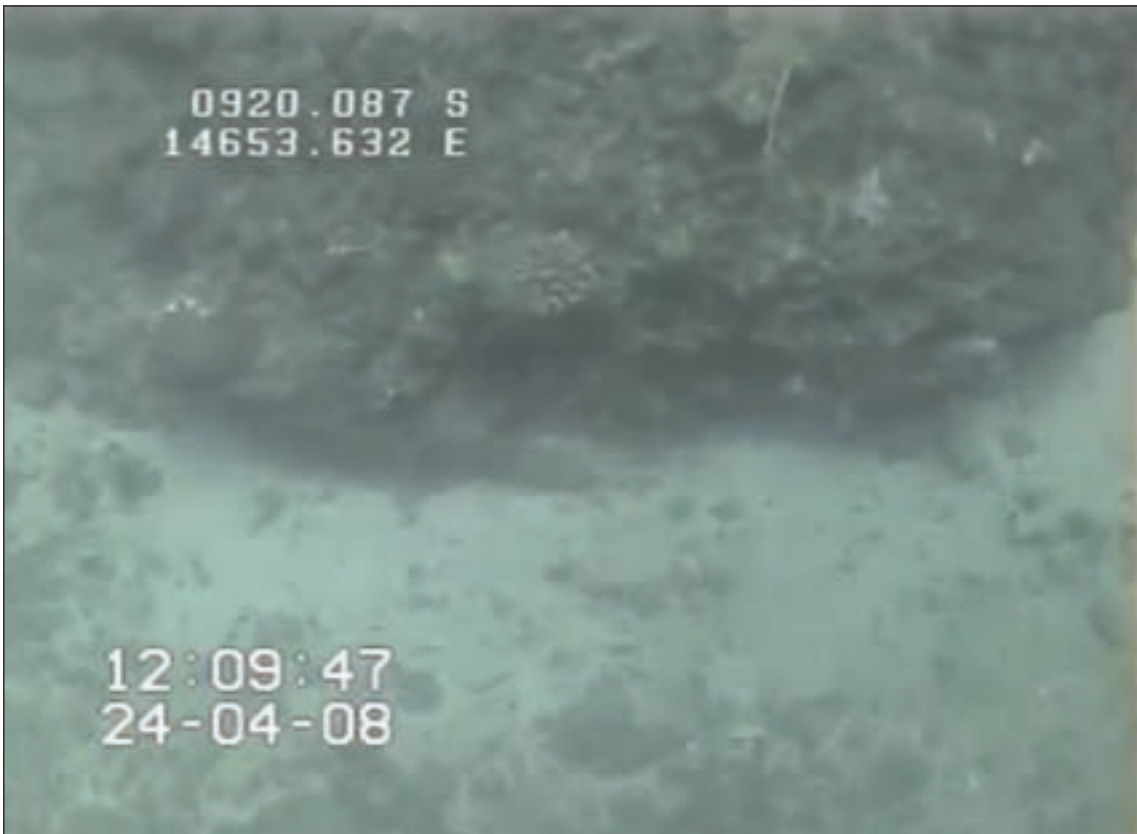
Plate 3.23 Drop camera video footage showing small isolated coral bommies with low coral cover

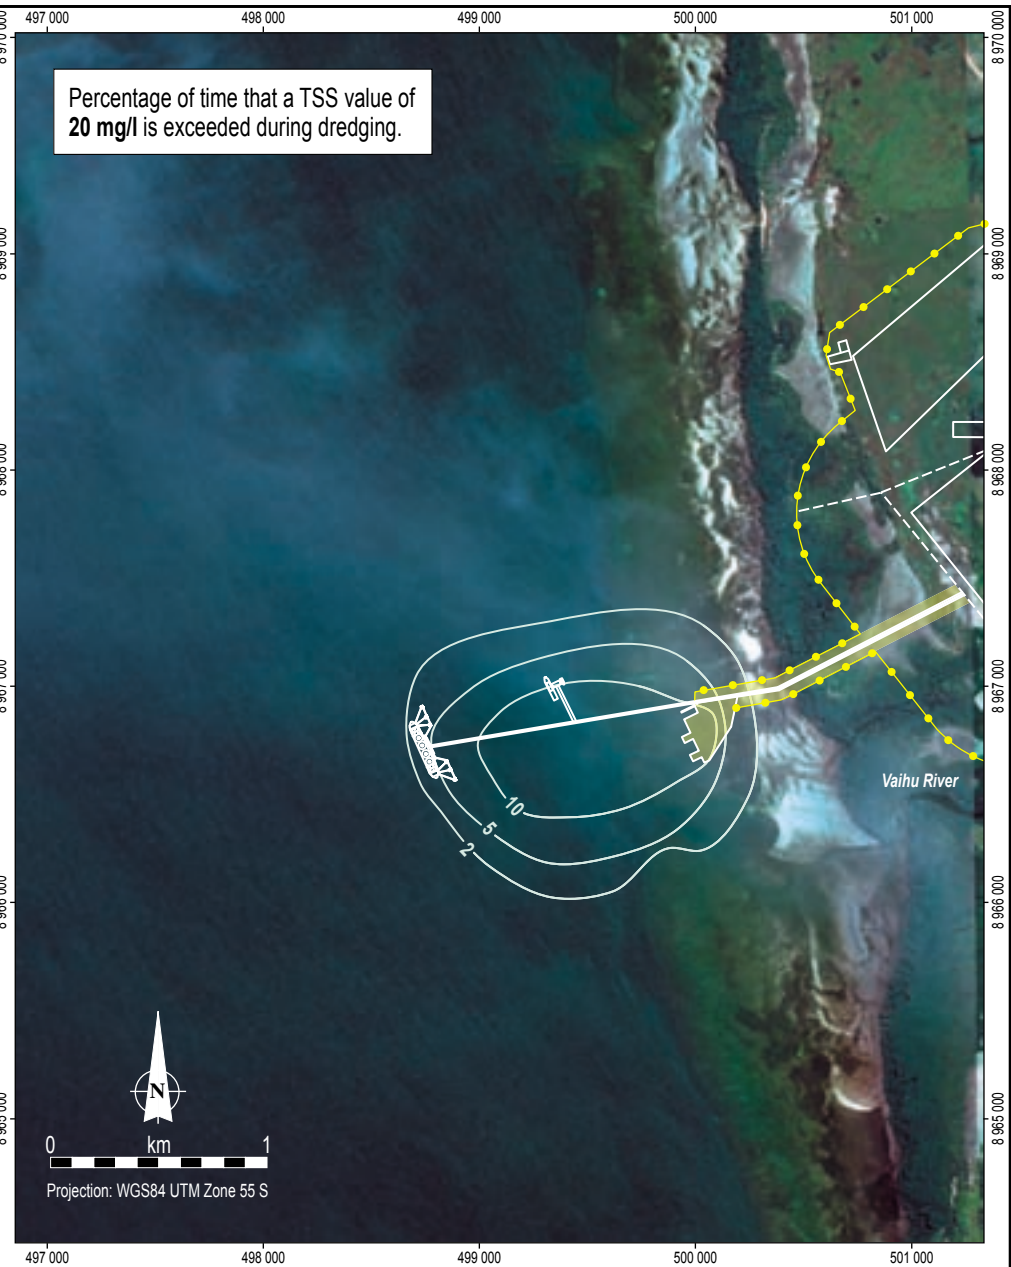
Source: Sediment plume data digitised from GEMS (2008). Indicative only.
 Note: Layout is indicative only.
 Final placement of all components is contingent upon pending soil and geological data.
